Surveying the Damage after a 7.8 Earthquake

Created in cooperation
with Eliot Sinclair

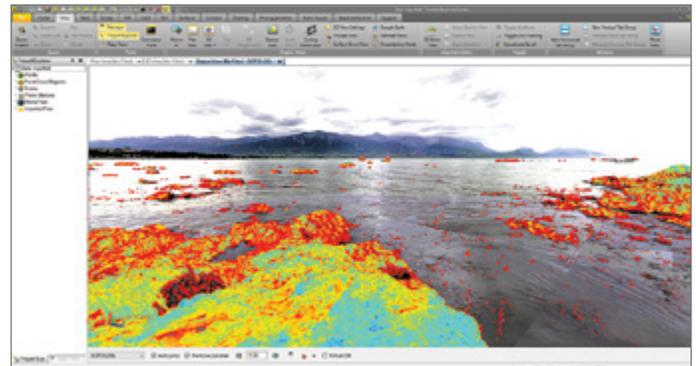
The SX10 scanning functionality was used to measure at low tide to the exposed rocks that proved valuable for a number of reasons. First, it saved a significant amount of time in data collection, replacing the need to manually measure points. Second, it provided much richer data than collecting single topo points on each rock outcrop. The third benefit was that comparisons could be done with the SBES data, which had been measured over the same positions at high tide, providing an extra redundancy on the data.

Drone data was also captured, and then combined with all sensor data to provide a real world picture of the state of the marina and surrounding area. This was then used to plan the remedial work required to get the marina up and running again. Over a year later, the South Island of New Zealand continues to rebuild. With the help of Eliot Sinclair's rapid response, comprehensive survey data and follow up monitoring work, the Marina was able to reopen quickly, resuming the crucial fishing and tourism business.
